Wiltshire Wildlife Trust

By Brook Sub-Catchment Action Plan

March 2020

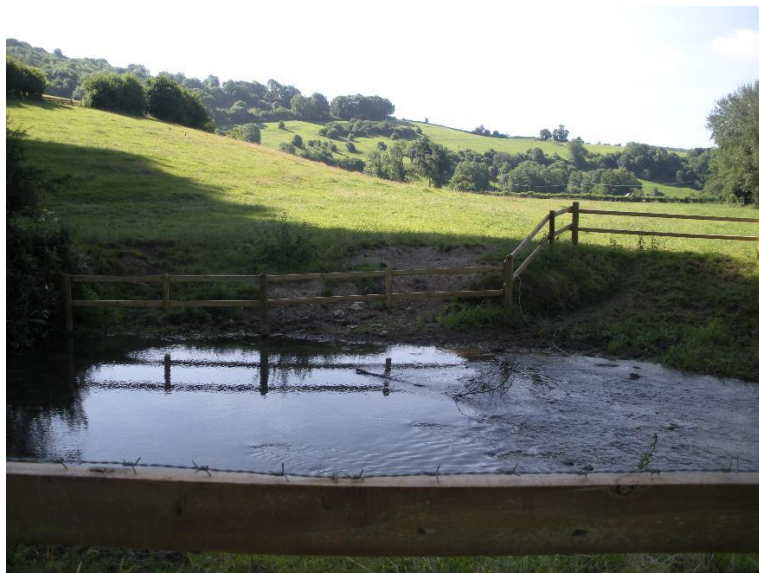
Figure 4. Image of fencing project done by By Brook Fly Fishers shortly after construction. © Environment Agency.

By Brook Fly Fishers' (BBFF) section of the river runs from just south of Slaughterford downstream to Drewetts Mill. These waters are relatively un-impacted by engineered structures, in contrast for FFF's waters, and sustain a healthy population of wild brown trout throughout as well as 'minor species' such as bullhead (*Cottus gobio*), minnow (*Phoxinus phoxinus*) and brook lamprey (*Lampetra planeri*). Livestock pressures are the main issue on this stretch of water, with livestock poaching leading to degraded banks, high silt levels and low diversity. BBFF, in partnership with the EA, carried out a small fencing project and installed a cattle drinking bay in 2017 (Figure 4), they continue to work closely with farmers and landowners to encourage fencing of marginal buffer strips along the water course

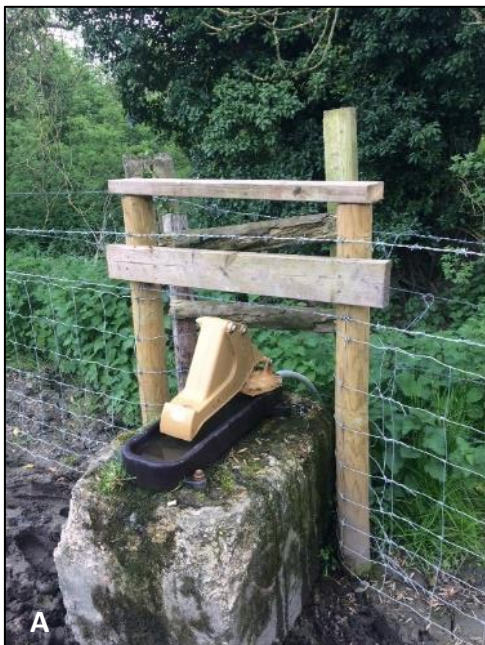
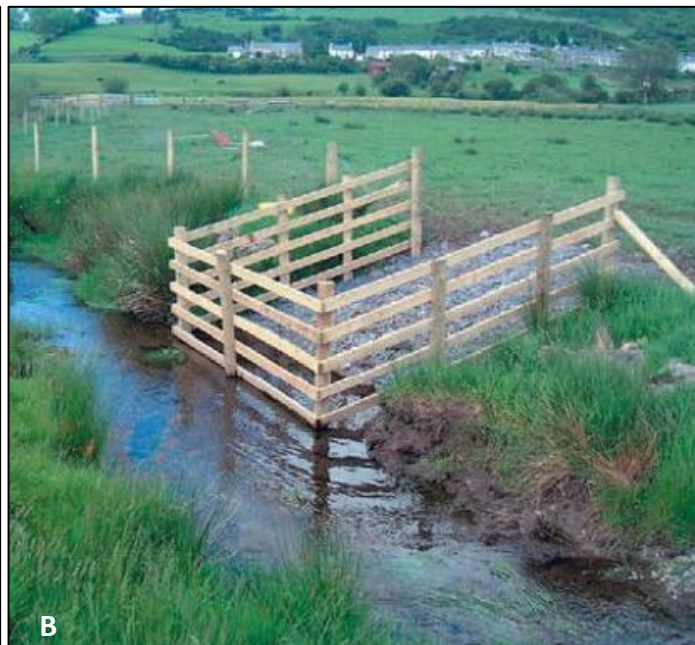
Example photos of possible livestock drinking solutions. A) Pasture pump (©WWT) and B) Cattle drinking bay (©CSF).

The pasture pump (A) is activated by the cattle pressing on the lever with their nose to release water into the trough below. A pipe takes water from the river to the pump meaning the livestock can be fenced away from the watercourse allowing for a 5m riparian margin in-line with the Farming Rules for Water. The drinking bay (B) gives livestock access to water whilst preventing them entering the channel and reducing erosion along the bank. A margin is able to be maintained either side of the bay.

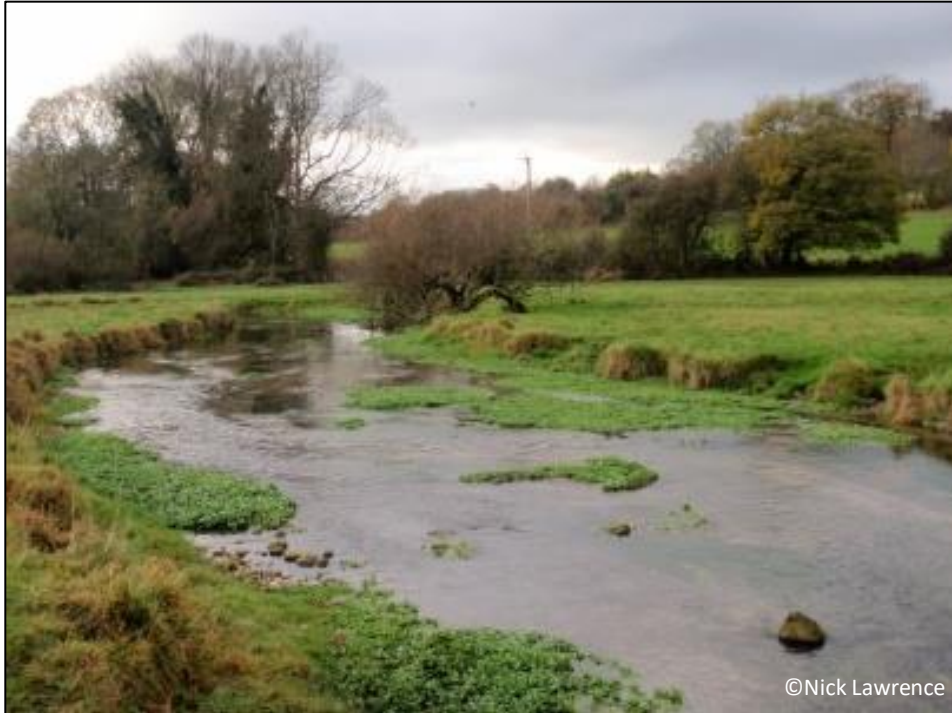
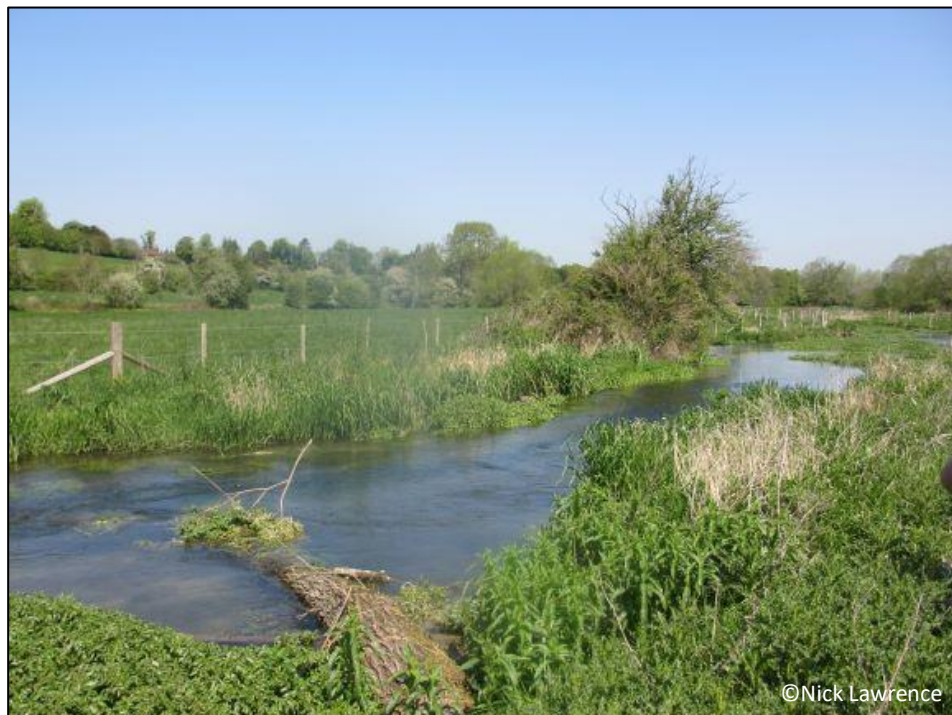
Example of successful livestock exclusion on the River Meon in Hampshire.

The top photo shows livestock poached banks prior to works, the bottom photo shows the same stretch of river after fencing with a healthy, diverse riparian margin.

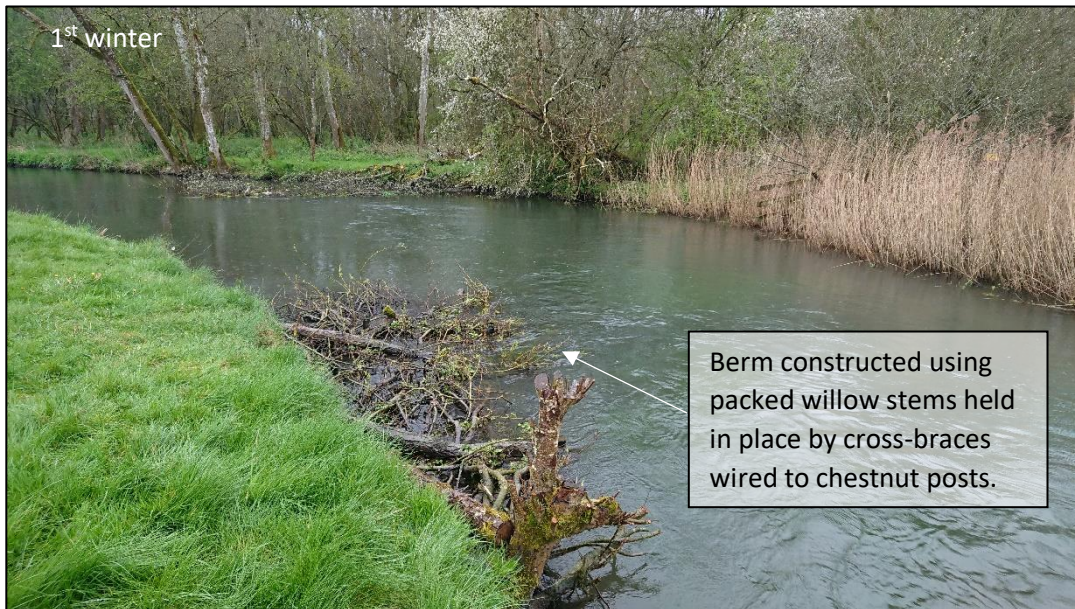
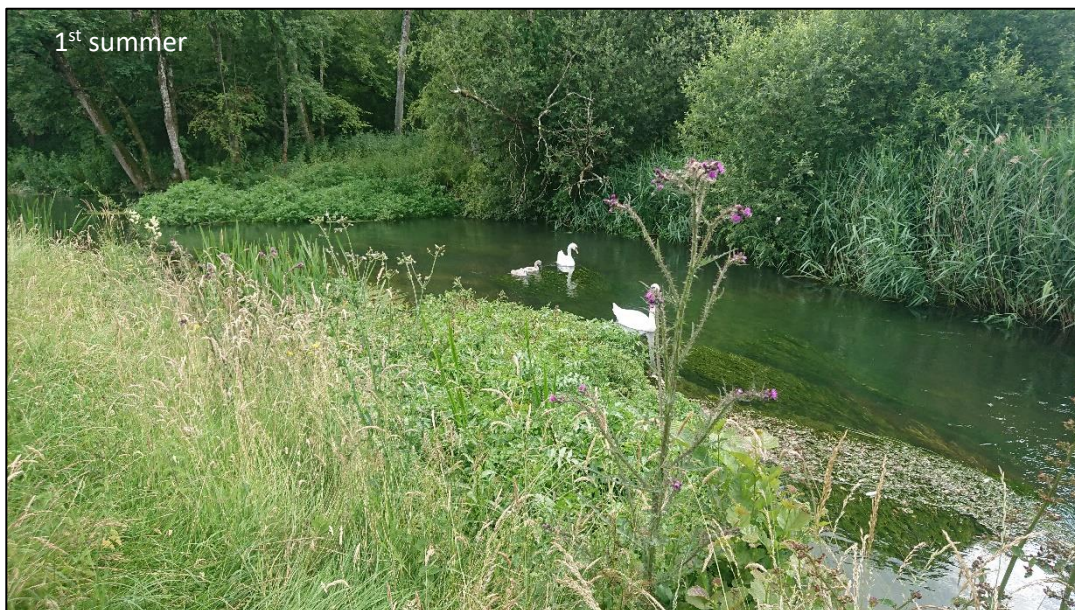
Example of woody berms installed on an eroded bank to provide improved in-channel and marginal habitat on the River Wylfe. Photos show the resulting vegetation growth after just 6 months.

River habitat improvements vary in form depending on the needs and characteristics of the particular stretch of river. On the By Brook the main improvements needed are a) sky lighting, opening pockets of the canopy to allow light into the channel and b) introducing in-stream habitat using hinged trees, tree crowns cabled in to place or and boulders. The By Brook is a spatey river so any interventions need to be securely fixed in place.

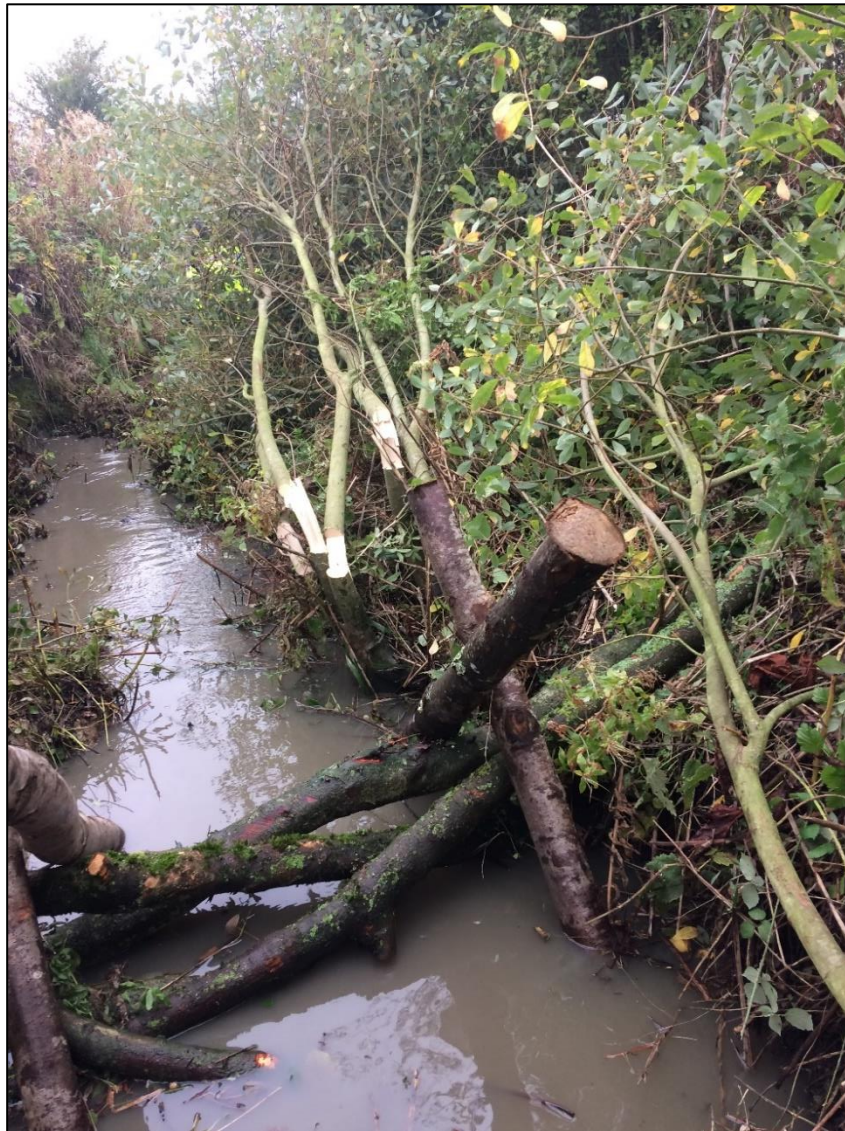
Example of a NFM technique. Leaky dams reduce the downstream flood peak by slowing peak flows. They are set above summer levels to allow low flows to pass uninterrupted. Ideally local materials such as tree root balls or hinged trees should be used to create a natural environment.

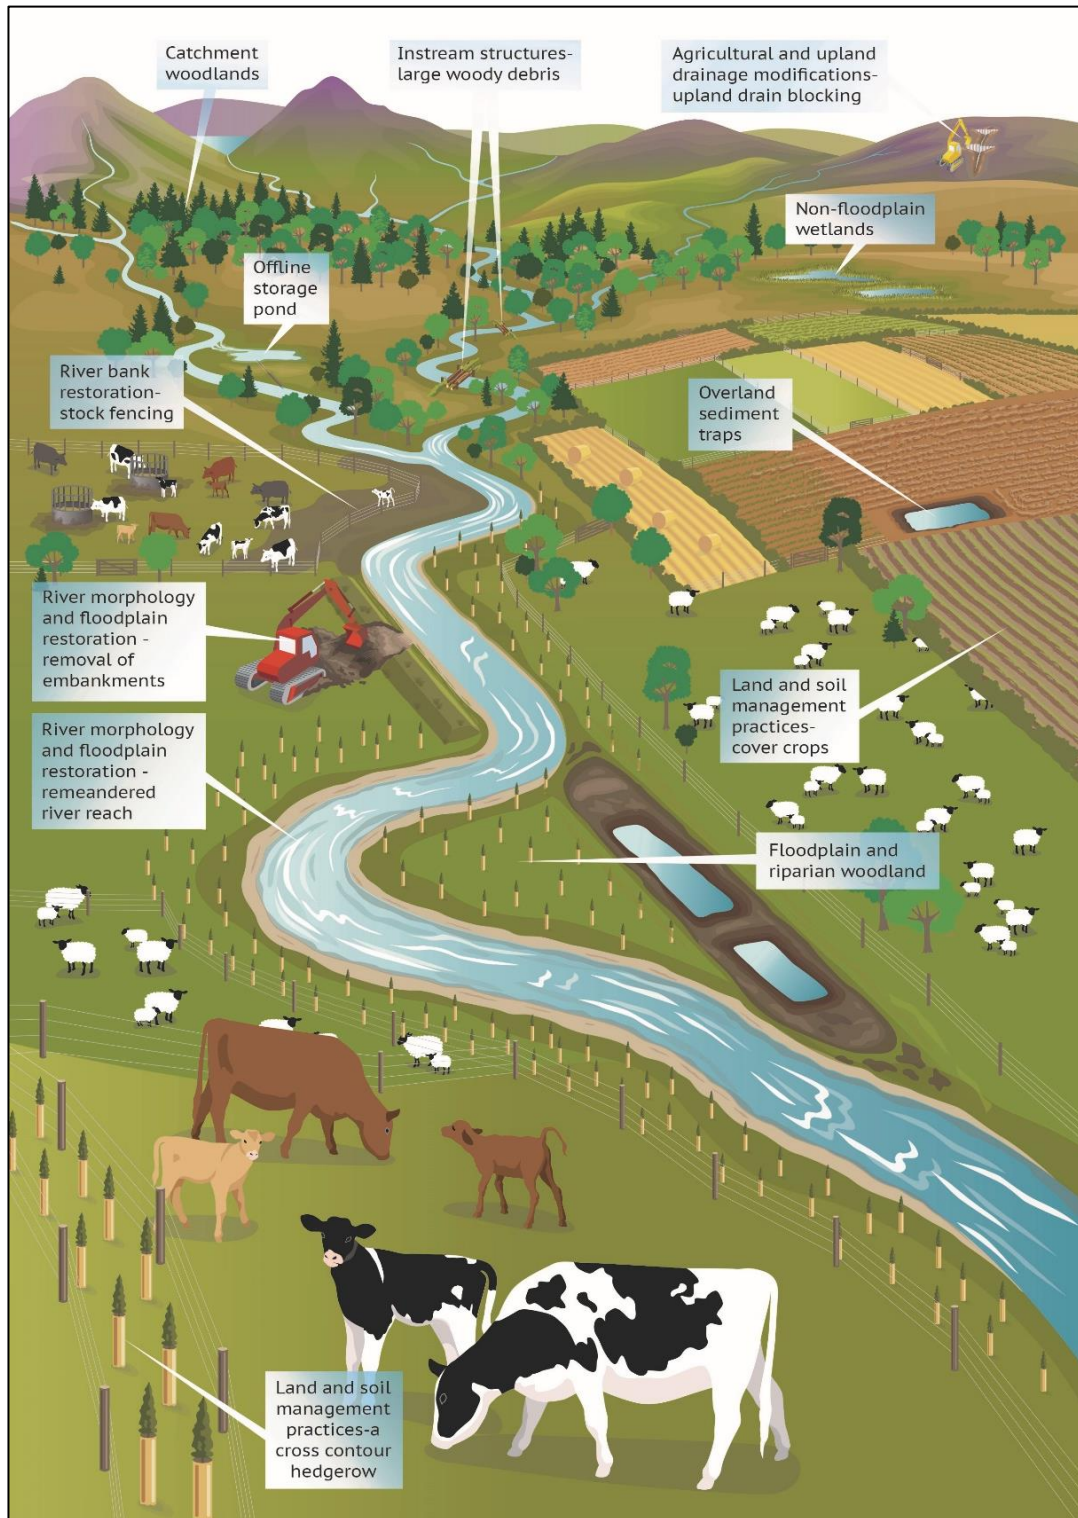
NFM techniques and how they fit into the rural landscape in practice.

- **Increasing soil infiltration** through free draining soil reduces.
- **Evaporation** from areas of vegetation.
- **Slowing water** by increasing resistance to its flow.
- **Storing water** using attenuation ponds, ditches and land.
- **Reducing water flow connectivity** by interrupting surface flows.

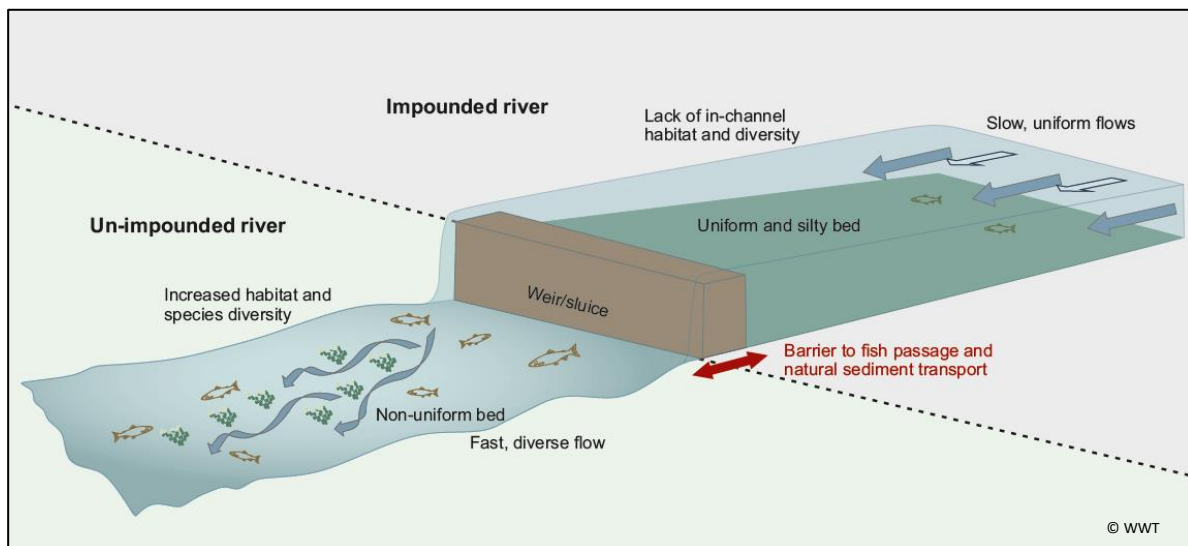
The impacts of an impounding structure on river habitat and the disruption of natural processes.

- Improved fish and eel passage up the river system.
- Restoration of the natural process of sediment transport down the river, reducing sedimentation issues.
- Removal of impoundments improves upstream and downstream habitat for a host of aquatic species.

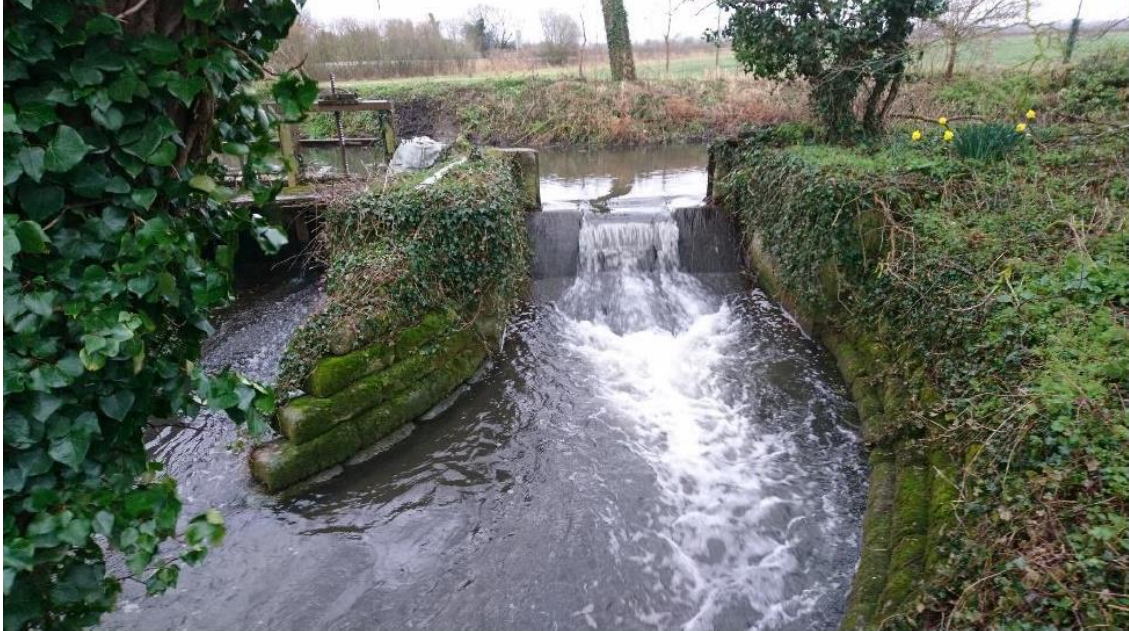
CASE STUDY – Weir fish passage easement carried out by river restoration contractors Cain Bioengineering in 2019 demonstrating what is possible on rivers like the By Brook.

Before: Weir bypass channel which was impassable to fish during most flow conditions.

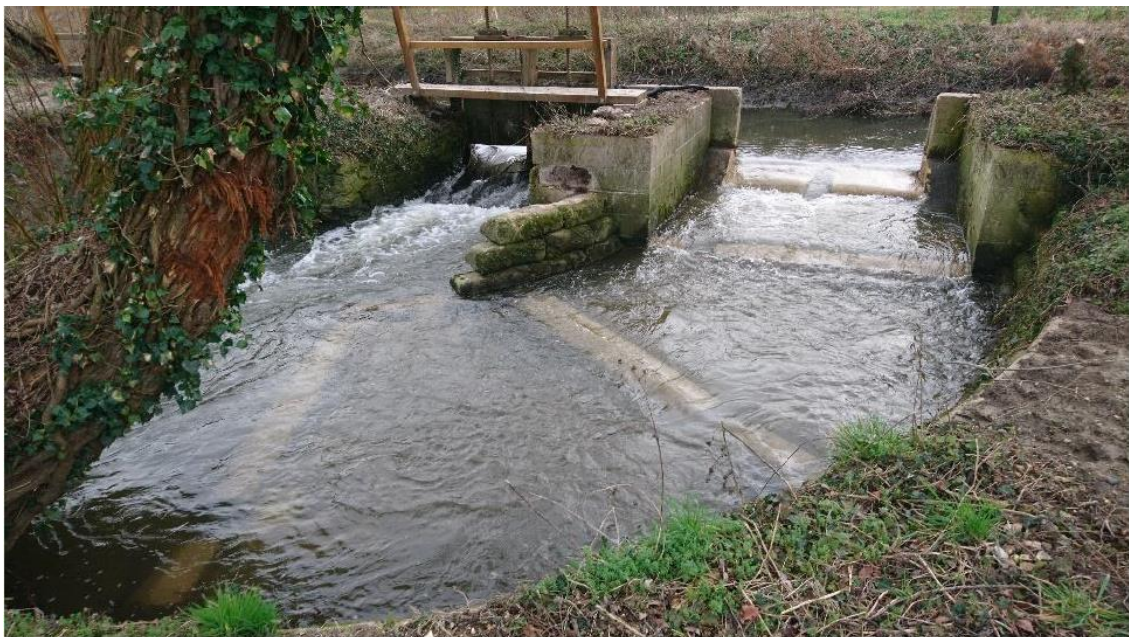
After: The weir height was lowered by approx. 250cm and gradient redistributed across a series of baffles. An alternate notch sequence was cut into the baffles and weir to manage flow speeds and ensure fish passage during low flows.

Total removal of a weir or similar impounding structure is the optimal solution, second to this is the creation of a bypass channel. In both cases notching, lowering or the creation of a step-down pool-riffle sequence with rock ramps can be used to manage the gradient whilst creating habitat that is immediately passable to a wide variety of fish.
